Sapperton Tunnel Report

Informal survey conducted on 30 November 2008

Extract from *The Trow* Number 144, Spring 2009

Tunnel Exploration

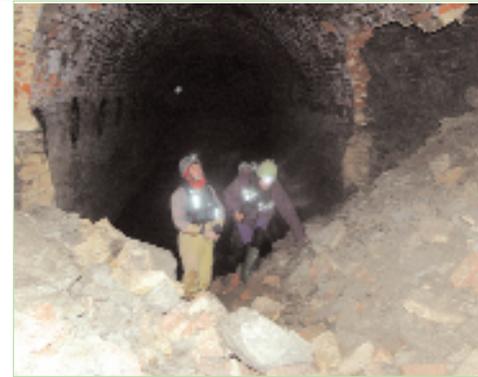
Above: Breach of both walls looking north

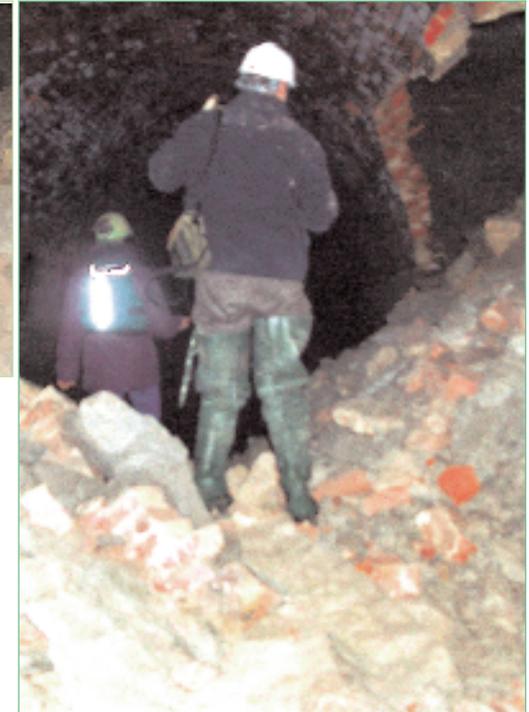
Right: Ken Burgin at the first fall

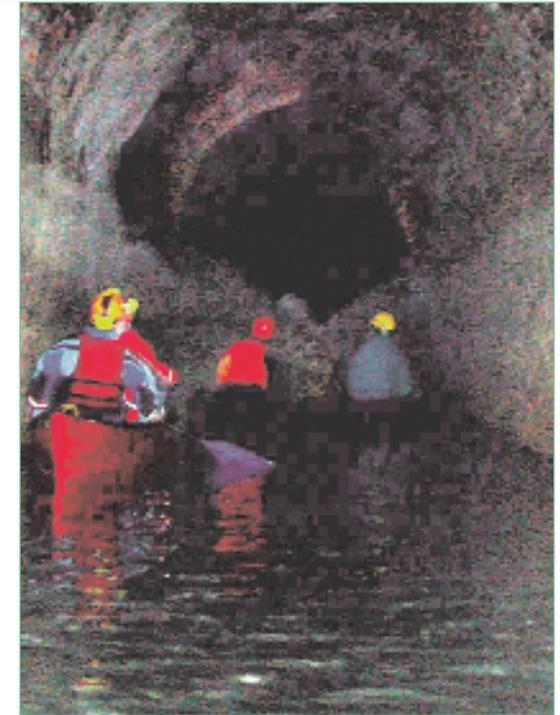
The tunnel is 174 chains long (a chain is 66 feet or approximately 20.3m), a little over 3.5km. It is not until chain 71, some 1.4km into the tunnel that the first significant obstruction is found in the form of a roof fall. Until the mid 1960s, it was possible to get right through Sapperton Tunnel although there were roof falls at the Daneway end and in the middle to climb over with some dating back to the time of the first world war. When I first knew the tunnel in the late 1970s, there were one or two side falls and a larger roof fall in the middle. This middle roof fall could be crossed by climbing over it into the void left by the collapsed material and back down the other side; the top of the fallen material being at roughly at the height of the top of the tunnel arch. Things have got a lot worse since then, we struggled over 5 roof falls and 3 side falls with some of the canoes before emerging on the other side - only to find the tunnel virtually empty of water. We were at about chain 84 and taking the badly distorted walls into account on either side, it would appear that this really bad section is constrained to a roughly 300m length.

Right: The first fall around Chain 71 (Photo: Ken Burgin)

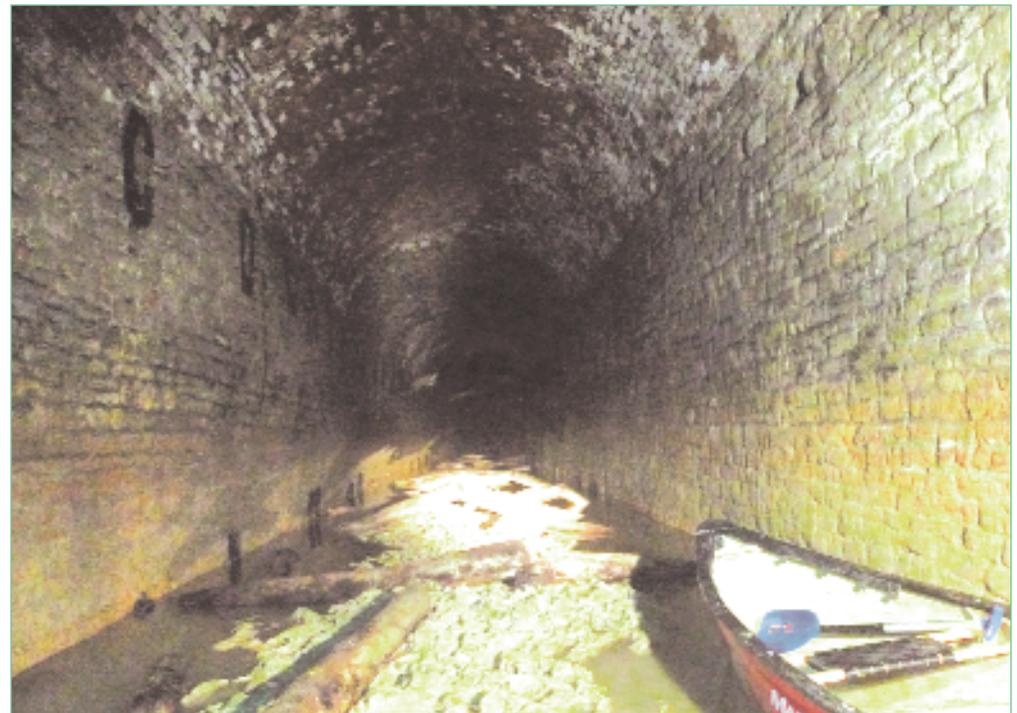
Beyond these central falls, the long arching continues for another 370m or so with the walls and roof looking in a quite reasonable condition. In the absence of water, the floor of the tunnel seen from this point is quite startling with broken timber struts rising from the bed of the canal for as far as the torches would illuminate. These are in the form of round tree trunks of perhaps 20-30cm diameter with the location of each indicated high on the tunnel wall above in black paint. In between, the Fullers Earth has raised the bottom up and it is probably this now which prevents the walls moving inwards.

Below: Wood beams to the west of the central fall area (Photo: Ken Burgin)
